## Gillette Castle's latest structural improvement hiding in plain sight

Written by Press Staff; September 22, 2020

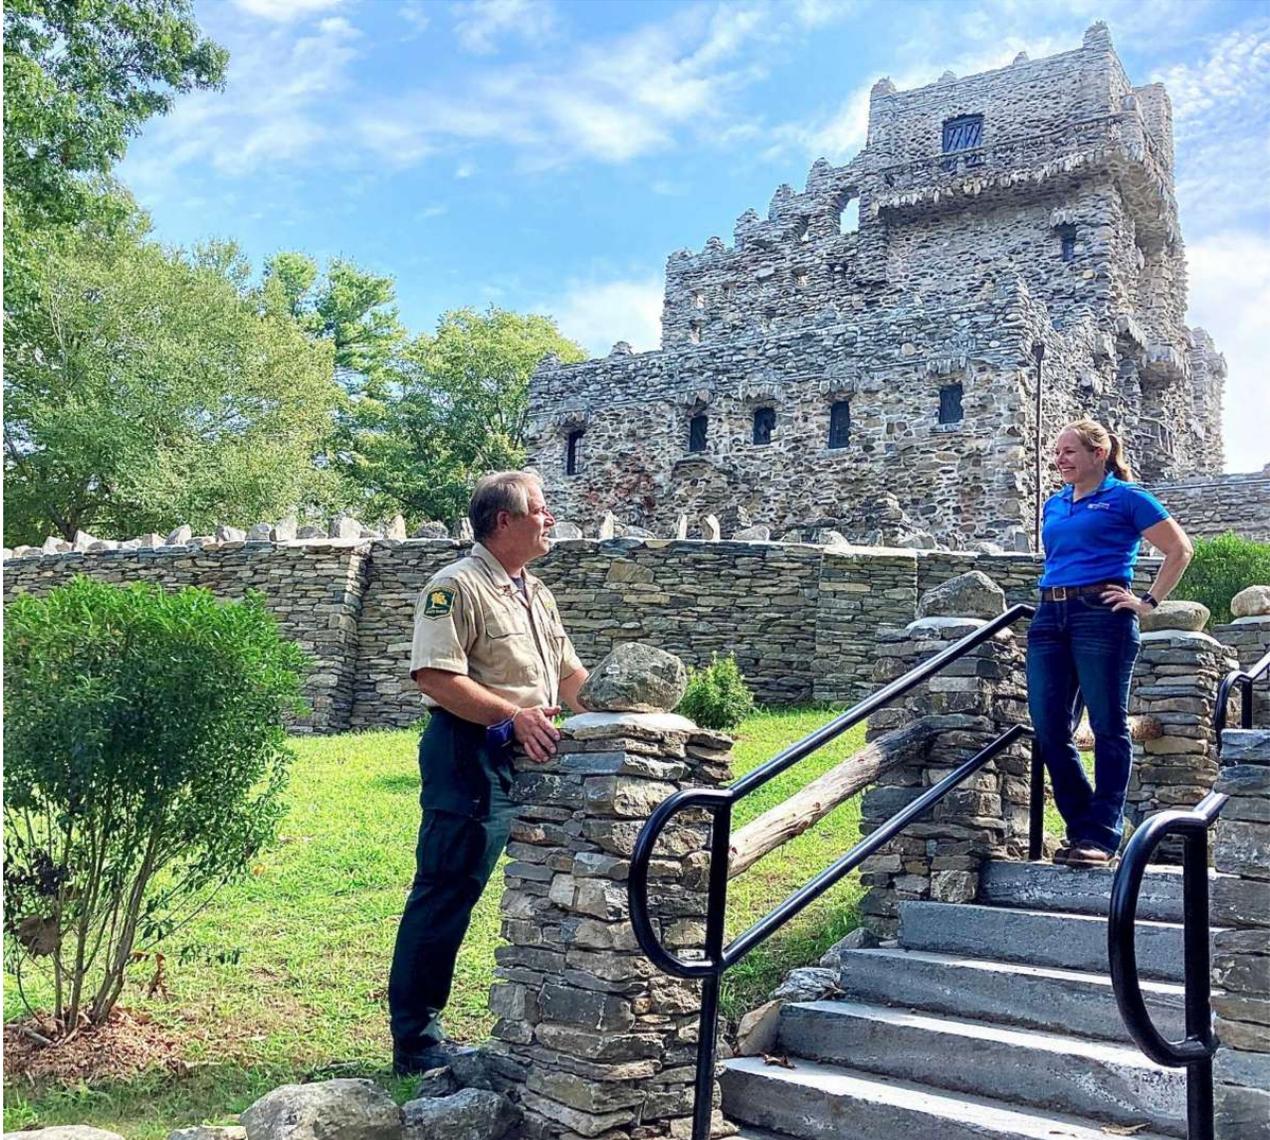
Jack Hine, left, supervisor of Gillette Castle State Park in East Haddam, meets with Heather Welsh of Mattern Construction, right, to look over the newly reconstructed staircase and concrete-reinforced retaining wall at William Gillette's century-old home.

Stones that Gillette's own construction crews had set in place in the early 20th century were removed, labeled and meticulously preserved, Young said. Then, a significant challenge loomed when it was found that a subsurface ledge required demolition - but without explosives.

"We didn't want to do any blasting because of the damage it could have done to the castle," Young said, adding the home stands relatively nearby. The solution was to have his crews drill a multitude of deep holes into the ledge, then inject them with a chemical that expanded, cracking the old foundation into small pieces that could be removed easily.

A new, reinforced concrete wall then was installed on the same location and covered with a veneer of stones from the original wall. All of the original rocks and flagstones were reused, Young said.

Visitors aren’t likely to notice some other aspects, Hine noted - such as an updated method by which the stairway is drained of rainwater. The filling between the flagstones is a substance called polymeric sand, not mortar, and helps prevent frost heaving and ice from forming.
